Wedge™ Series Make up Acceptance

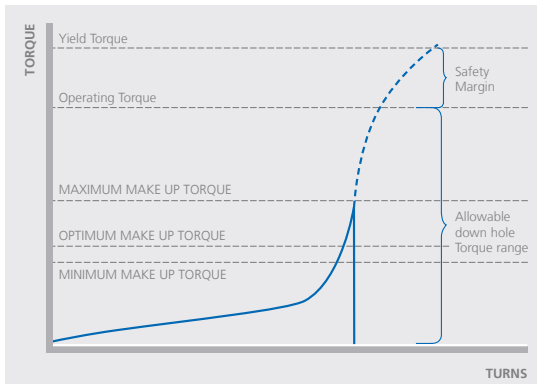
Essentially the thread build portion of a Wedge™ Series computer graph has a smooth 'ski slope' transition into a rapid torque climb as the connection assembles. A gradual change in slope on the upper portion of the torque-turn graph may be observed. Additionally, some Wedge™ Series connections have visual indicators of correct make up position which should also be checked after applying the correct make up torque. Refer to the connection specific running guidelines for information on make up indicators applicable to each connection.

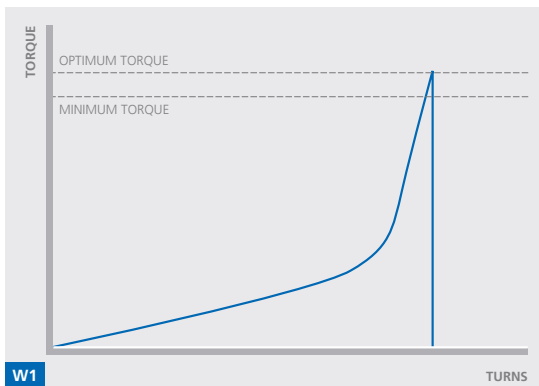
COMPUTER GRAPH WEDGET[™] SERIES

ACCEPTABLE

Standard profile graph for a Wedge[™] Series connection.

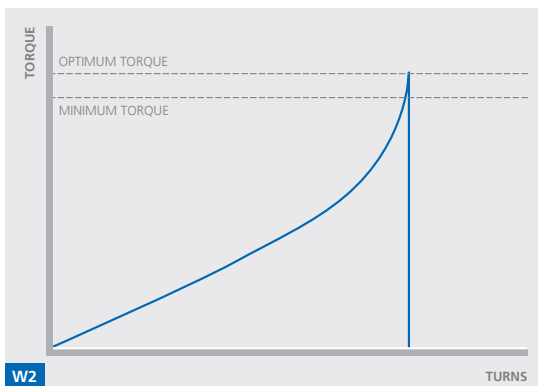
COMPUTER GRAPH WEDGE™ SERIES

If a graph similar to the one above is observed, the make-up indicator should be checked to ensure the connection has fully engaged. If found to be the case, the assembly can be accepted. Thereafter, all similar graphs can be accepted as long as any make up indicators are checked and indicate the connection has reached the correct make up position.

If no indicator is present the connections should be broken out and inspected and if found to be acceptable the make-up loss should be marked on the pin end and the connections reassembled, thereupon the make-up loss mark can be checked to ensure correct assembly point has been reached. The make-up loss for the connection is indicated on the product data sheet.

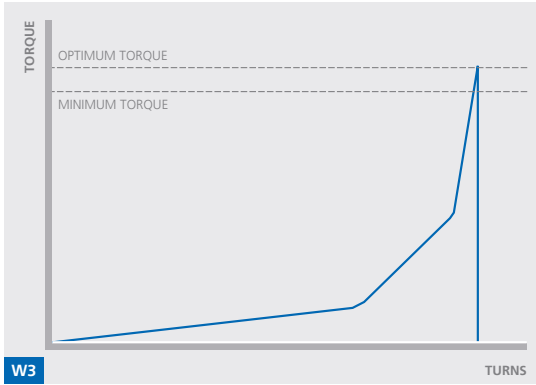
COMPUTER GRAPH WEDGE™ SERIES

ACCEPTABLE

Wedge™ Series 600 connections may also exhibit a more distinctive make up profile such as above.

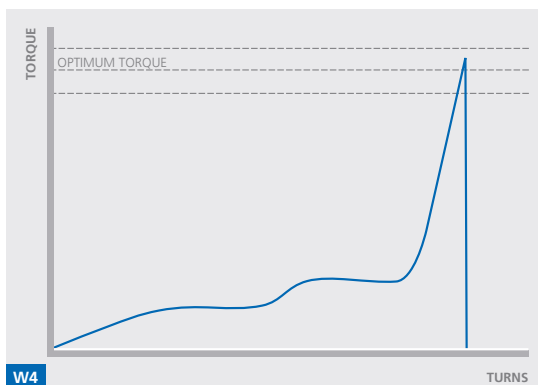
COMPUTER GRAPH WEDGE™ SERIES

ACCEPTABLE

Minor oscillations during assembly.

Possible Causes

- Pipe movement during spin in.
- Excessive thread compound application.
- Pipe OD contact from external equipment.
- Excessive spin in speed.

Recommendations

- Reduce quantity of thread compound applied respecting application guidelines.
- Stabilize pipe during make up.
- Reduce spin in speed.

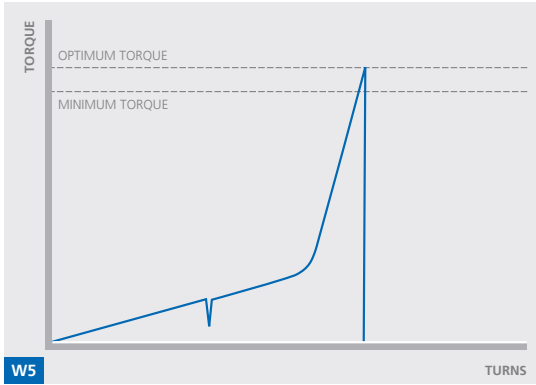
COMPUTER GRAPH WEDGET[™] SERIES

ACCEPTABLE

Tong slip returning to same thread build path.

Possible Causes

- Clogged tong dies.
- Worn tong dies.
- Incorrect dies or tong jaws.
- Tong not level.
- Snub line movement.
- Wet or oil covered pipe OD.

Recommendations

- Clean or replace dies.
- Check tong jaws are correct for pipe OD.
- Ensure tong is level.
- Clean pipe OD.
- Check snub line.

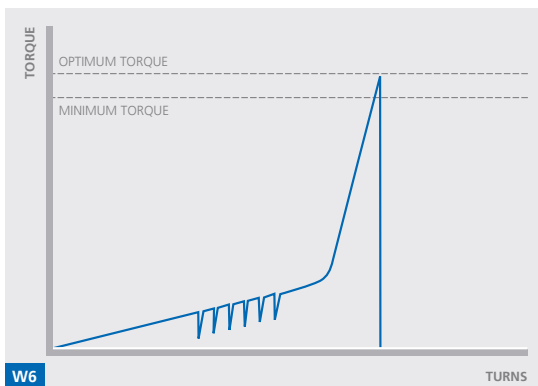
COMPUTER GRAPH WEDGE™ SERIES

UNACCEPTABLE

Multiple tong slips.

Possible Causes

- Clogged tong dies.
- Worn tong dies.
- Incorrect dies or tong jaws.
- Tong not level.
- Snub line movement.
- Wet or oil covered pipe OD.

Recommendations

- Break out, clean and inspect both connections for damage.
- If no damage found re-apply thread compound then re-make up connection.

Take action to prevent reoccurrence

- Clean or replace tong dies.
- Ensure tong and back up is level and dies contact pipe OD evenly.

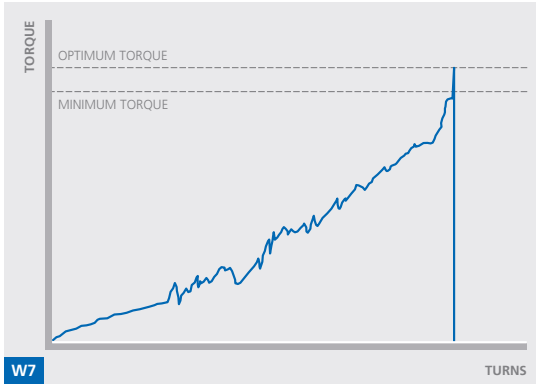
COMPUTER GRAPH WEDGET[™] SERIES

UNACCEPTABLE

High thread interference.

Possible Causes

- Galled threads.
- Damaged threads.
- Pipe movement during spin in.
- Incorrect thread compound.
- Contaminated thread compound.
- Contaminated connections.
- Misalignment.

Recommendations

- Break out, clean and inspect both connections for damage.
- If no damage found re-apply thread compound then re-make up connection.
- Ensure thread compound is correct type and is not contaminated.
- Stabilize pipe during make up.
- Ensure threads are completely clean prior to applying thread compound.
- Remedy misalignment.

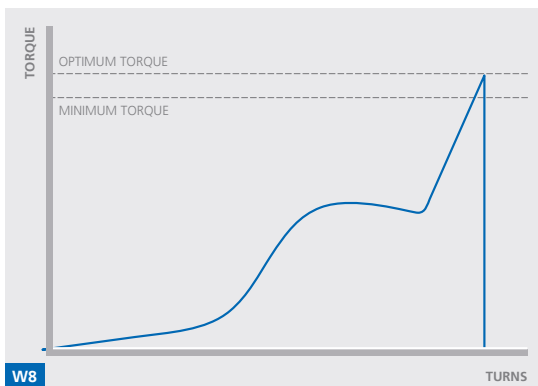
COMPUTER GRAPH WEDGE™ SERIES

UNACCEPTABLE

Excessive hump effect.

Possible Causes

- Pipe movement during spin in.
- Incorrect thread compound.
- Contaminated thread compound.
- Running compound not homogenised.
- Excessive thread compound.
- Misalignment.

Recommendations

- Break out first graph displaying this profile, clean and inspect both connections for damage.
- If no damage found re-apply thread compound then re-make up connection.
- If no damage found accept further graphs of similar type.
- Ensure thread compound is correct type and is not contaminated.
- Reduce quantity of thread compound applied ensuring all threads are covered.
- Stabilize pipe during make up.
- Ensure threads are completely clean prior to applying thread compound.
- Remedy misalignment.

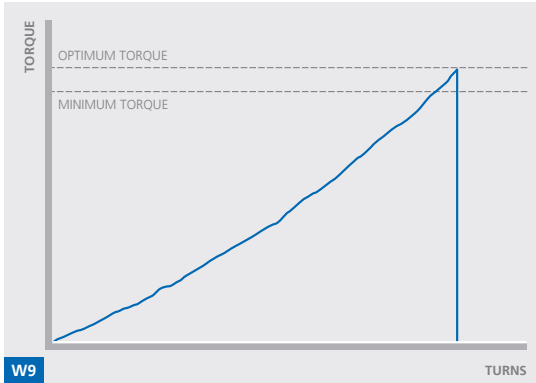
COMPUTER GRAPH WEDGET™ SERIES

UNACCEPTABLE

The graph above has no identifiable 'wedging' effect; therefore, the make-up indicator should be checked to verify correct make up position has been attained then the connection should be broken out, inspected and if both pin and box are acceptable re-assembled.

For subsequent make-ups, reduce the amount of thread compound if possible, as this could be causing this graph profile.

If the second graph exhibits the same profile repeat disassembly, upon a third make-up exhibiting the same graph profile the connection

should be broken out, inspected and if both pin and box are acceptable the pin connection should be replaced. The replaced pin connection can be used on a subsequent make up.

If the connection has no make-up indicator, mark the final make-up position of box face onto the pin end then break out the connections. Check the distance from pin nose to the scribed mark against the indicated make-up loss from the data sheet, if the connection did not attain correct final make up position segregate pin connection for further analysis and replace with a new joint.

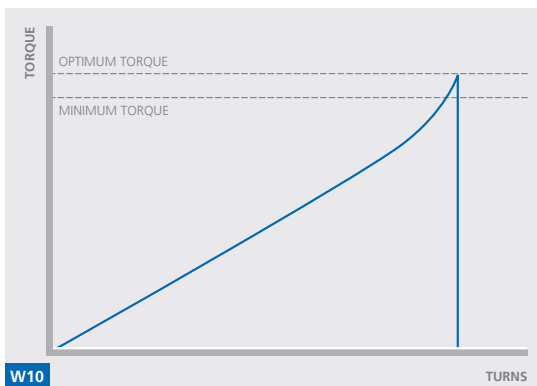
COMPUTER GRAPH WEDGE™ SERIES

UNACCEPTABLE

The graph above has minimal evident 'wedging' effect. Therefore, the make-up indicator should be checked to verify correct make up position has been attained prior to the connection being broken out, inspected and if both pin and box are acceptable re-assembled. Thereafter all similar make up graphs can be accepted as long as correct assembly position is verified as having been attained by checking the makeup indicator for each make up.
